Contract #: 04-0120F4Cty: SF/ALA Rte: 80 PM: 13.2/13.9File #: 1.28**WELDING INSPECTION REPORT****Resident Engineer:** Casey, William**Address:** 333 Burma Road**City:** Oakland, CA 94607**Report No:** WIR-028733**Date Inspected:** 09-Nov-2012**Project Name:** SAS Superstructure**OSM Arrival Time:** 700**Prime Contractor:** American Bridge/Fluor Enterprises, a JV**OSM Departure Time:** 1730**Contractor:** American Bridge/Fluor Enterprises, a JV**Location:** Job Site**CWI Name:** Fred Michels**CWI Present:** Yes No**Inspected CWI report:** Yes No N/A**Rod Oven in Use:** Yes No N/A**Electrode to specification:** Yes No N/A**Weld Procedures Followed:** Yes No N/A**Qualified Welders:** Yes No N/A**Verified Joint Fit-up:** Yes No N/A**Approved Drawings:** Yes No N/A**Approved WPS:** Yes No N/A**Delayed / Cancelled:** Yes No N/A**Bridge No:** 34-0006**Component:** SAS OBG**Summary of Items Observed:**

WELDING INSPECTION REPORT

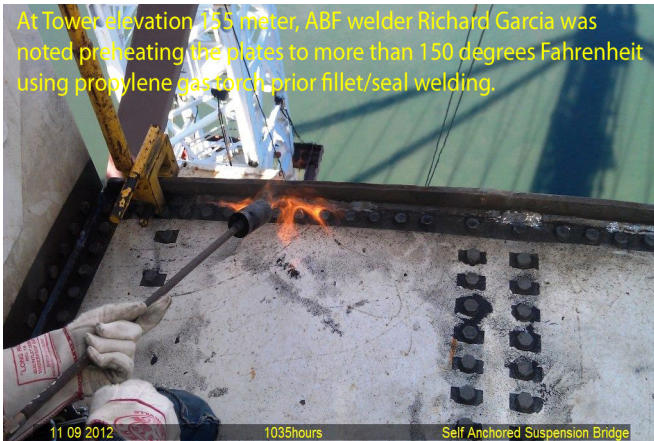
1. Tower elev. 155M – West shaft east side fillet joint weld cover QA verified
2. Tower elev. 155M – North shaft west side fillet joint weld cover QA verified
